STATE OF DELAWARE
PUBLIC SERVICE COMMISSION

Subject: In the Matter of the Corrective Action Order Issued to Iacono –
Summer Chase Apts. L.P. in Accordance with 26 *Del. Admin. C.*
§8001 (Filed October 30, 2015)

**Gas leak detection survey of the underground gas distribution system at
Canterbury Village Apartments in Bear, DE.
Prepared for Boulden Propane**

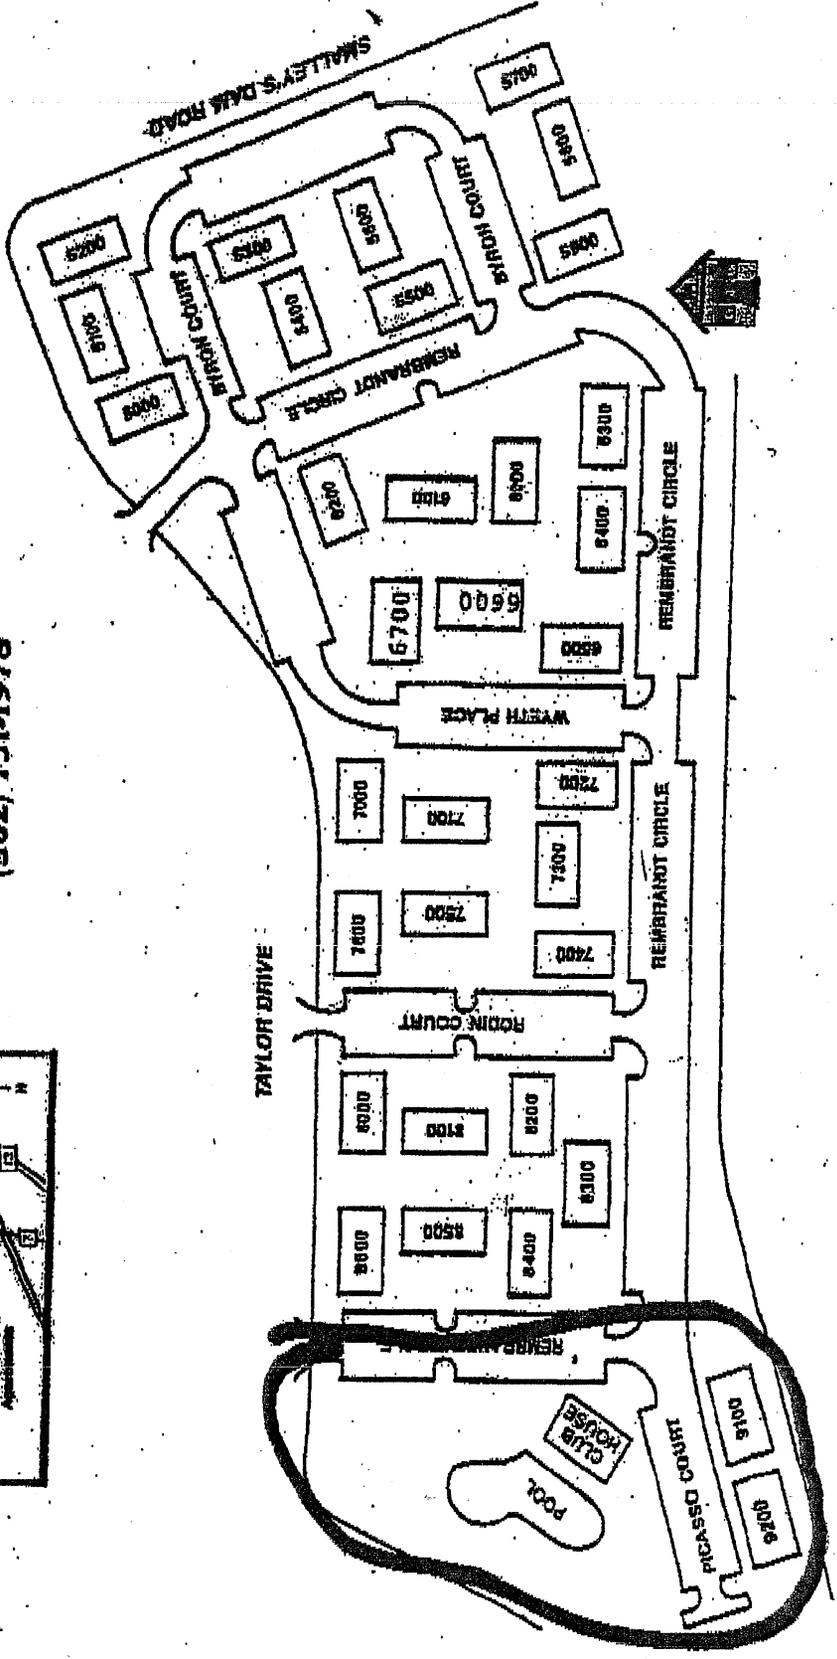
2012 Tested underground line at office, Bol area and Apts 9200 & 9100
 Tested every 10 years Test Passed

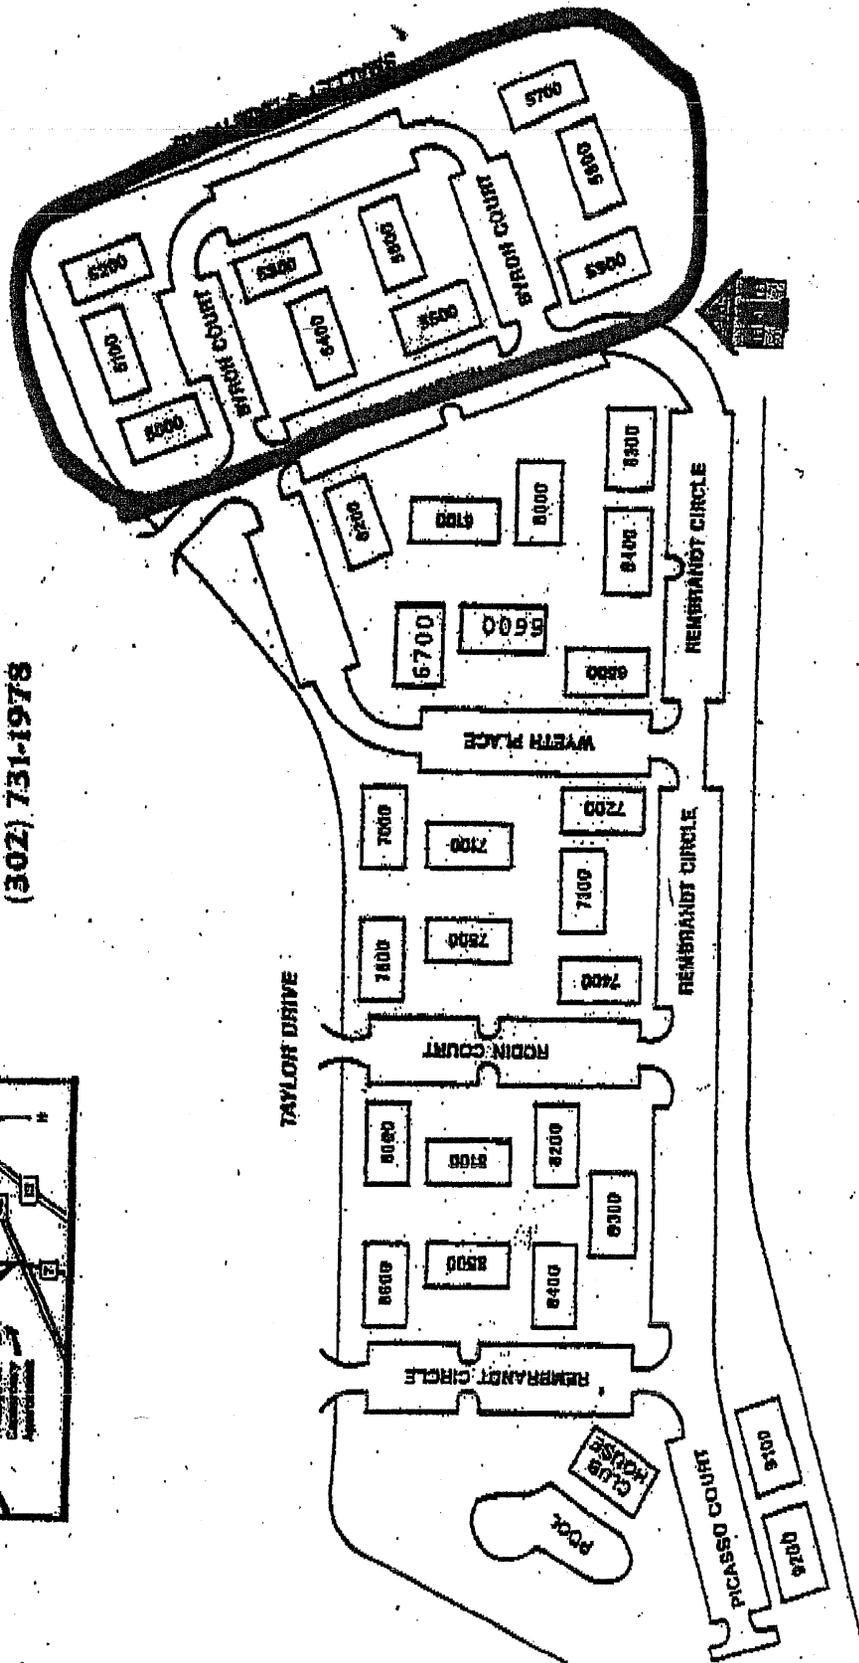
2011-Tested underground live, using CGI & Bar hole Tester,
 Tested every 10' to 15'. Tested Apts 5000 to 5900

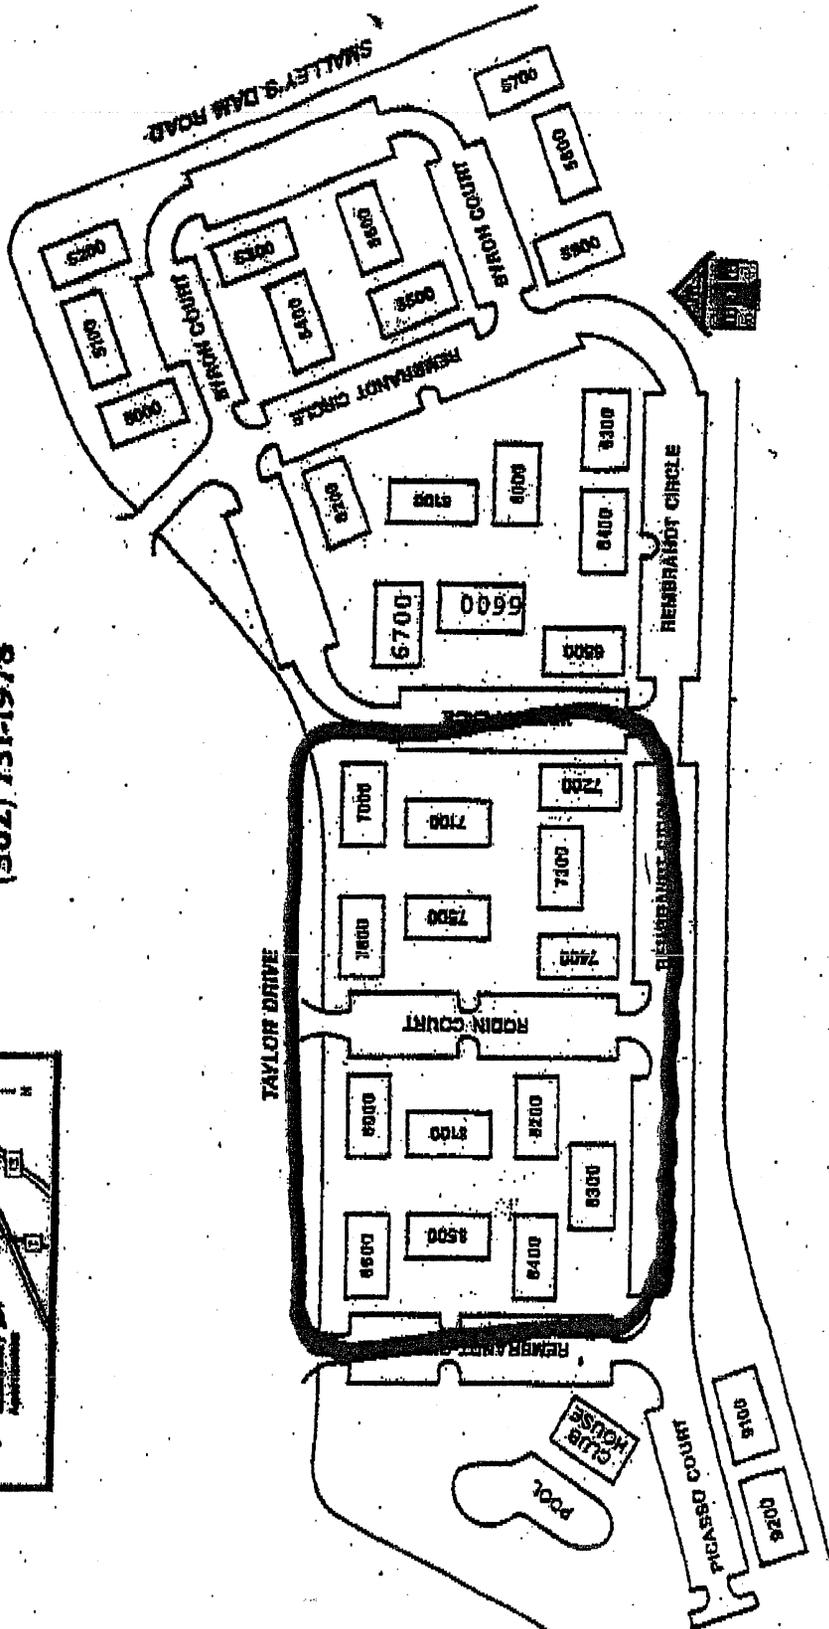
2016-Tested underground lines using CBI and Bar hole tester
 had no reads. Tested April 2000 to 8600
 Tested every 10' to 15'

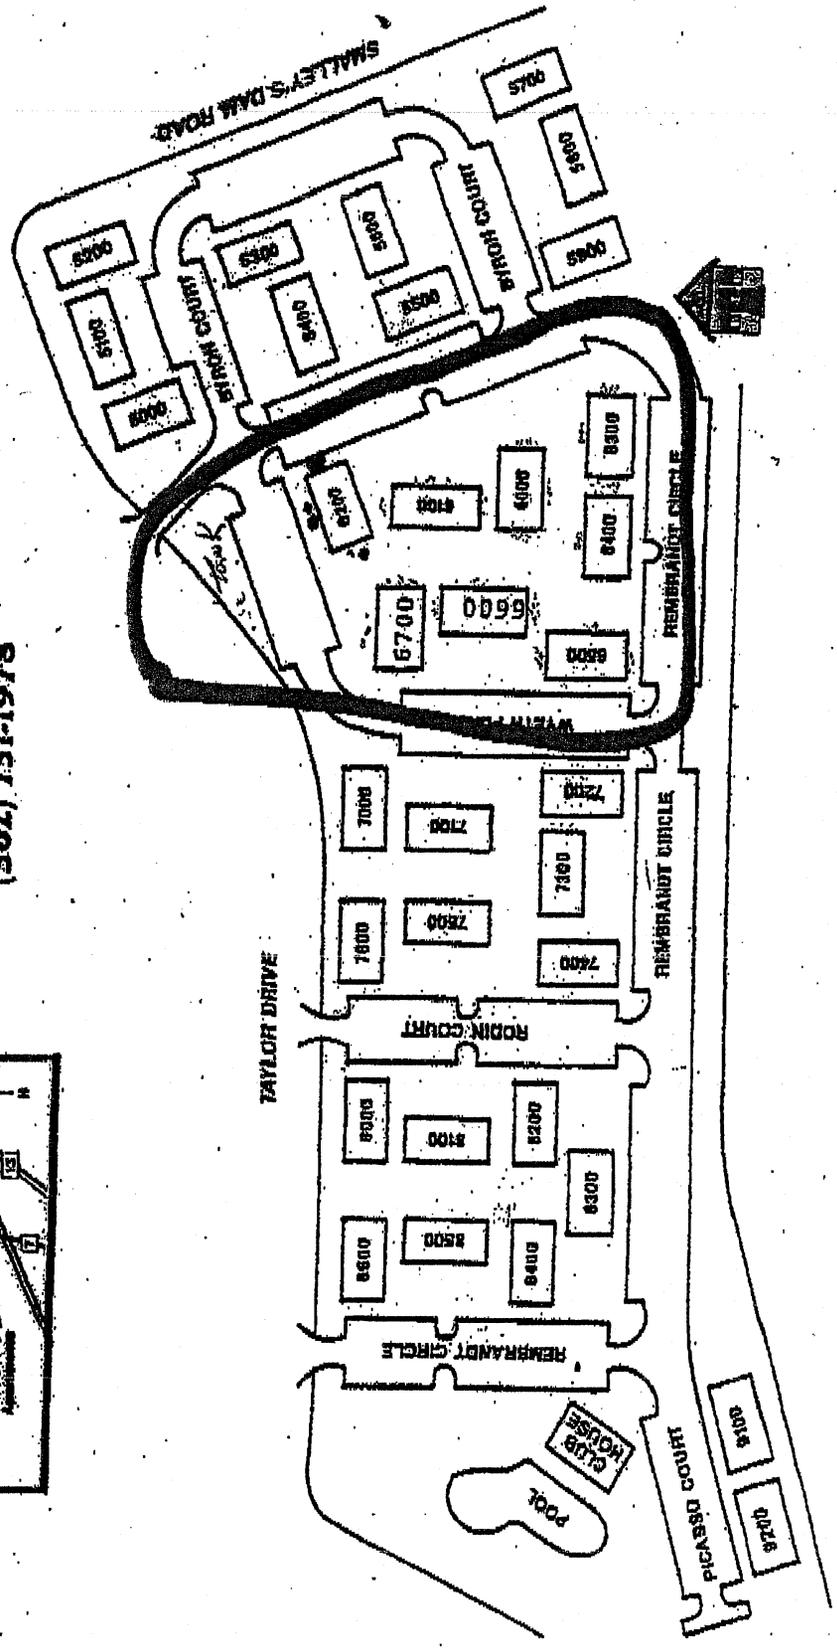
Apt 6000 to 6700

2009

Tested underground
line: using Bar hole and
C.G.I. Test Passed
Tested every 10' to 15'
